佛寺水库坝顶路面裂缝调查及分析

摘要: 在对佛寺水库坝顶裂缝情况详细普查的基础上, 通过挖探坑和灌浆方法, 对裂缝进行了针对性的调查分析。结合普查与调查分析成果, 对佛寺水库坝顶裂缝进行了成因分析。得出如下结论: (1) 坝顶裂缝并未延伸至原砂石路下垫层, 亦即未影响到心墙部位, 表明坝顶混凝土路面裂缝不是心墙与坝壳料沉降不均匀造成的。(2) 坝顶混凝土路面砂砾石层在顺河向分布厚度不均, 是造成坝顶混凝土路面裂缝的内因。车辆超过坝顶混凝土路面设计荷载是造成其裂缝的外因。同时由于坝顶在上游侧设置有防浪墙, 车辆通过坝顶过程中本能地偏向下游侧行驶, 这也是造成坝顶混凝土路面不均匀裂缝的外因。(3) 建议对坝顶裂缝进行处理, 限制坝顶路面通过社会车辆, 同时加强监测与巡视检查, 防止坝顶裂缝进一步发展。

Investigation and analysis of pavement crack on dam crest of Fosi Reservoir

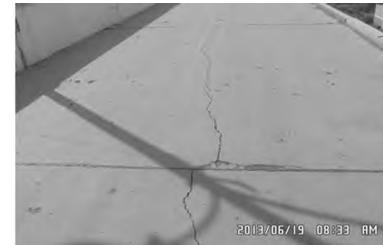
图 2 主坝混凝土路面裂缝走向

佛寺水库 2001 年对原有路面加高 25 cm 砂砾石垫层, 并在其上部浇筑 10 cm 厚混凝土, 形成 6.0 m 宽坝顶路面。经调查, 坝顶公路沿坝轴线方向 90% 已出现裂缝, 统计共有裂缝 167 条, 裂缝宽度 5~30 mm, 局部可达到 40 mm。坝体中部个别段裂缝两侧路面可见 1~5 mm 高差。防浪墙墙面抹灰出现网状裂纹。下游路肩为混凝土连续墙结构, 与路面之间大部分裂开, 其裂缝宽度一般在 40 mm 左右, 最大为 60 mm。坝顶裂缝特征见图 2~图 5, 主要裂缝情况统计见表 1。

通过钻孔ZK4 1和ZK4揭示的混凝土路面以下砂砾石层分布情况看,坝顶混凝土路面砂砾石层在顺河向分布厚度不均,这是造成坝顶混凝土路面裂缝的内因。

从佛寺水库多年运行情况看,坝顶路面未设置任何路障,经常通过各类车辆,其中不乏运输煤炭的重型货车。车辆超过坝顶混凝土路面设计荷载是造成其裂缝的外因^[15]。同时由于坝顶在上游侧设置有防浪墙,车辆通过坝顶过程中本能地偏向下游侧行驶,这也是造成坝顶混凝土路面不均匀裂缝的外因。

(3) 建议对坝顶裂缝进行处理, 限制坝顶路面通过社会车辆, 同时加强监测与巡视检查, 防止坝顶裂缝进一步发展。

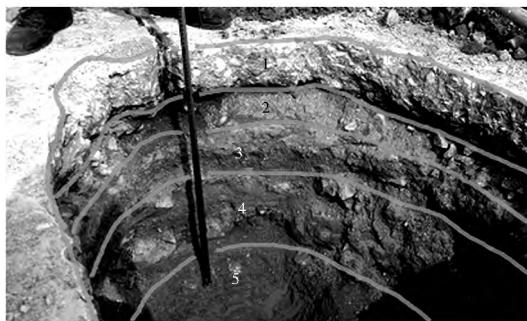
图7 BTK1探坑断面

如图7所示,坝顶路面至黏土心墙顶面约70 cm,根据揭露土层状况,从上至下可分为5个主要人工填筑层,即混凝土路面、路面下10 cm厚砂砾石垫层、原砂砾石路上垫层、原砂砾石路下垫层、黏土心墙。其中原砂砾石路面上层颗粒较细,粒径多为2~5 mm;下层较粗,多为大于2 cm的碎石,并且含有粒径为5~10 cm的较大块石。

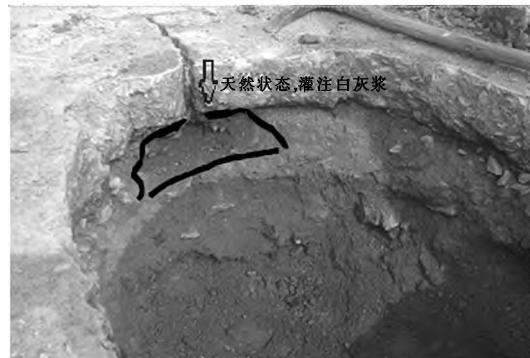
图8 BTK1探坑白灰浆浸润范围

裂缝贯通混凝土路面,混凝土路面下探坑侧壁未发现贯穿裂缝,白灰浆液沿混凝土路面裂缝渗入下部垫层,沿下部垫层向两侧有扇形渗入现象。BT K1探坑在原砂石路上、下垫层中未见明显渗入现象,见图8;BT K2探坑在原砂石路面不均匀处,白灰浆液沿原砂石路上垫层碎石边缘也有部分渗入现象,原砂石路下垫层及其下部未见渗入,见图9。

从挖坑灌注石灰浆现场试验结果^[9~11]看,坝顶裂缝并未延伸至原砂石路下垫层,亦即未影响到心墙部位,可见坝顶混凝土路面裂缝不是心墙与坝壳料^[12~14]沉降不均匀造成的。

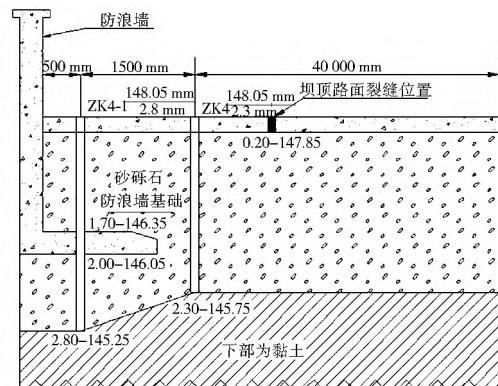
图10 钻孔ZK4 1、ZK4砂砾石层剖面

布置钻孔ZK4 1,与ZK4连线垂直坝轴线,距离ZK4钻孔1 5 m,距离防浪墙0 5 m,ZK4 1钻孔原砂砾石路垫层厚2 6 m,ZK4钻孔原砂砾石路垫层厚2 1 m。可见,原砂砾石路厚度在垂直坝轴线方向上并不均匀。示意剖面见图10。在沿坝轴线方向上,原砂砾石路厚度也不均匀,左坝段厚度为1 5~2 3 m,右坝段厚度为0 7 m。
